## Test Report

No. SHAMLC1702339501

The following sample(s) was/were submitted and identified on behalf of the clients as : pvc composit door jamb

### Formaldehyde Emission

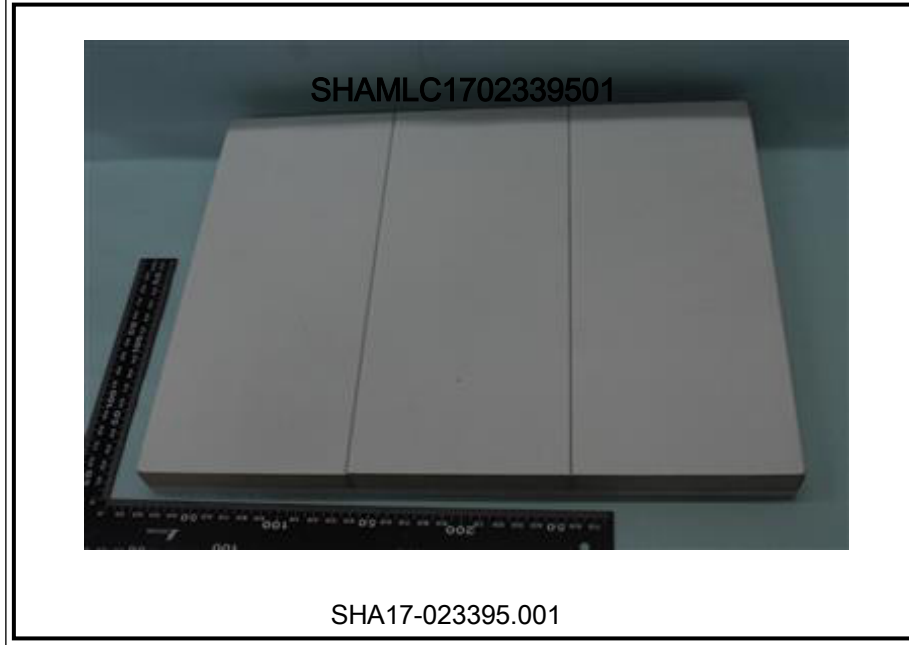
Sample photo:

Specimen No.	SGS Sample ID	Description
SN1	SHA17-023395.001	White solid board
